Navajo Abandoned Uranium Mine

Site Screen Report

Tom Morgan 1 AUM Site

August 2010

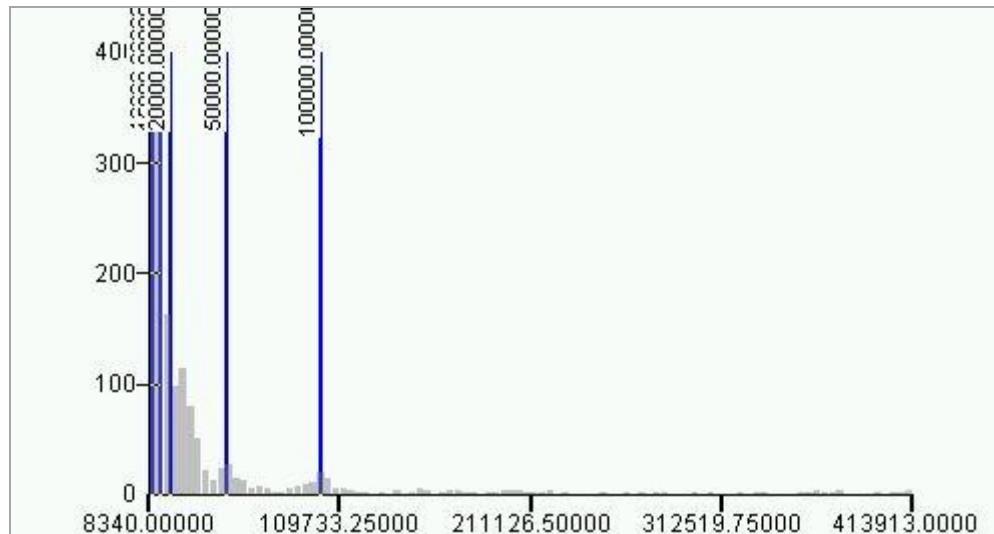
Distribution Chart and Statistics:

The following chart and statistics were generated by ESRI ArcGIS 9.3.1, and show the general distribution of the site gamma radiation measurements. The horizontal X axis represents the gamma radiation reading levels in cpm (lowest levels to the left). The vertical Y axis represents the frequency of each gamma radiation level.

Count:	1502
Minimum:	8340.00000
Maximum:	413913.00000
Sum:	55624249.00000
Mean:	37033.45473
Median:	17230.00000
Standard Deviation:	56775.95247

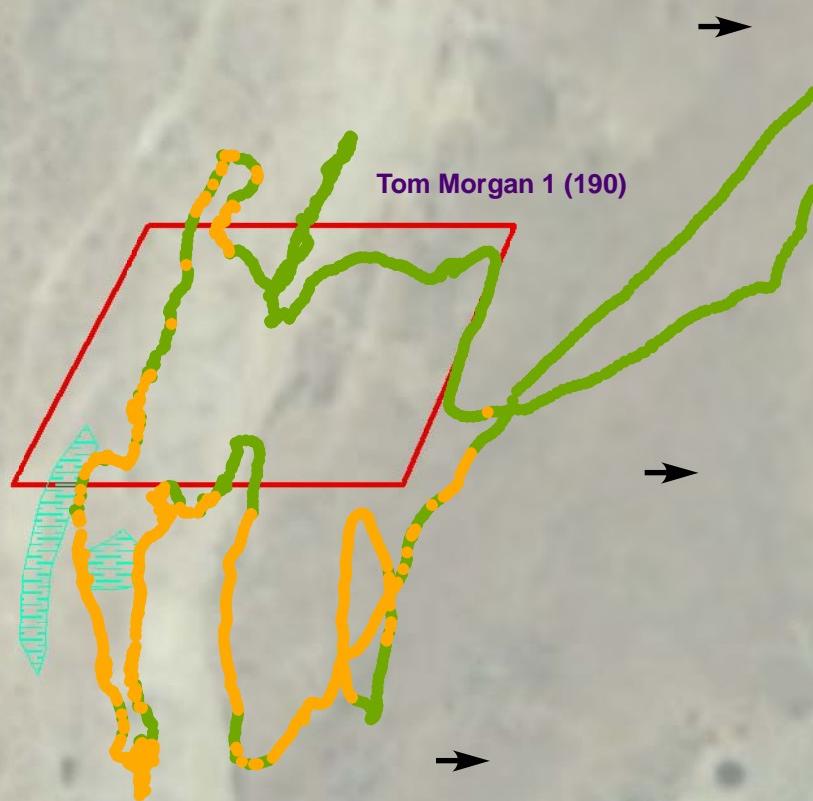
Figure 1 - Gamma Radiation Measurements, Above Two Times Background
Tom Morgan 1 (190)
Red Mesa Chapter, Navajo Nation

A total of 1,502 gamma radiation measurements were collected from the mine site, ranging from 8,340 cpm to 413,913 cpm. Measurements collected in the vicinity of the reclamation cap were found at levels up to approximately 100,000 cpm, in the wash below up to 15,000 cpm, and at isolated yellow rocks at levels up to approximately 400,000 cpm. The measurements are represented in Figures 1 and 2.
